RE: ADA Technical Review of Faces of Hope Building

In response to your request, please find a formal technical review of the parking lot, the pathway from the parking lot, the access ramps to the customer entrance, and areas in the facility that are accessible to the public for the Faces of Hope office located at 209 West Main Street in Boise.

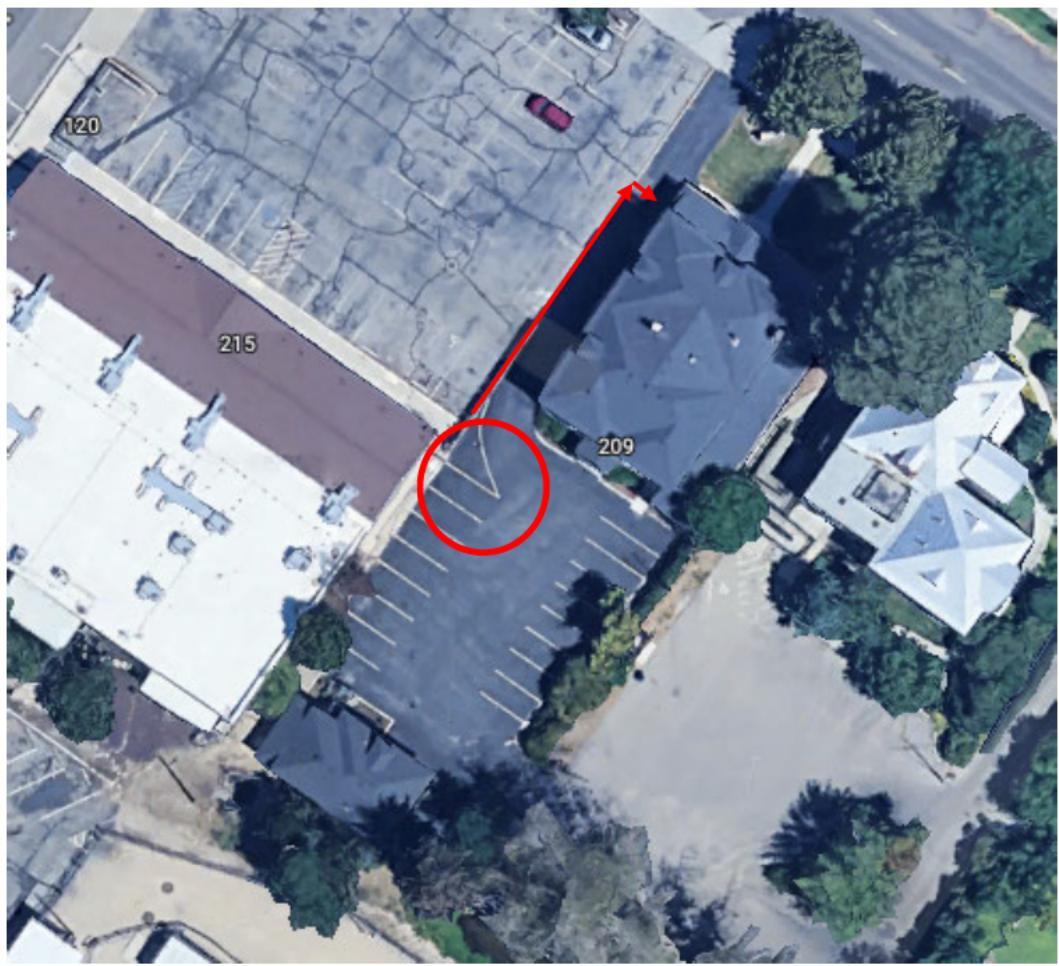
Figure 1 - Arial view of parking lot

Noncompliant Findings: The parking lot located at the rear of the building has no van accessible parking space.

The photos below show an arial view (Figure 1) of the recommendation van accessible parking space and the accessible route to the ramp, and a surface view (Figure 2) of the recommended parking space. The cross-slope of the recommended parking space is 1.45 degrees, which is less than required maximum 1.48 degrees or 2.08 percent.

Recommendation: Designate a van accessible parking space in the rear of the building closest to the wheelchair ramp that provides access to the front entrance of the building. This parking space must comply with Section 502, including the width of the parking space and access isle, van accessible signage, and an accessible route directly connecting from the access isle to the wheelchair ramp at the front of the building.

- a. We have identified and marked a handicap parking spot in the rear parking lot with an area large enough for loading/unloading.
- 2. Ramp
 - a. The existing ramp at Boise location does not meet current ADA slope and handrail requirements. However, because the property is designated as a historical structure, it is grandfathered under ADA Title III regulations, which allow certain modifications or exemptions to preserve the historical integrity of the building. As such, alterations to the ramp are not required unless they can be made without compromising the historic character of the site.

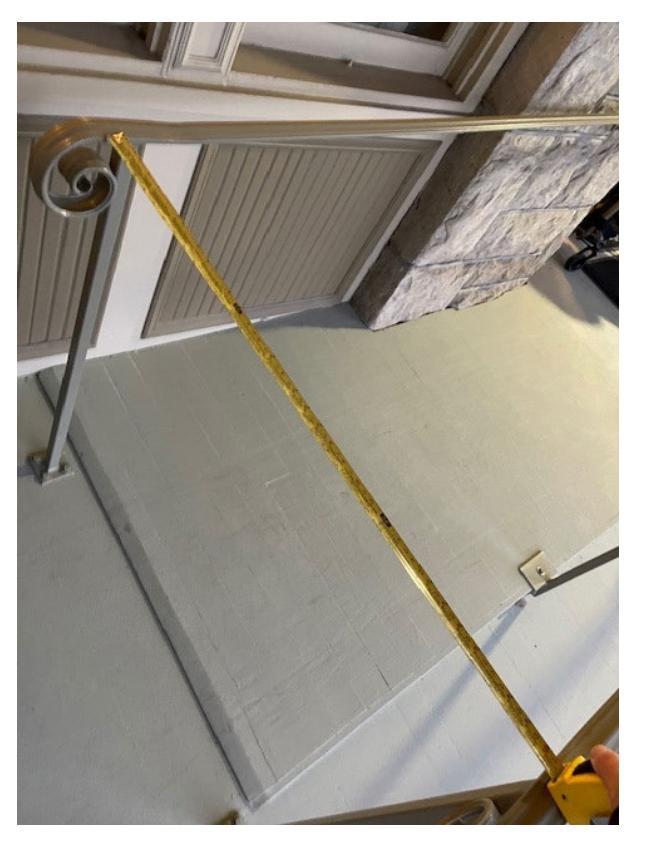
Figure 3 - Photo of ramp width being measured

Noncompliant Findings: The width of the ramp from street level to the front porch of the building between handrails is only 32 inches, and must be at least 36 inches. The width of the ramp from the porch to the front door is 34.5 inches. The photo below (Figure 3) shows the ramp from the porch to the front door being measured.

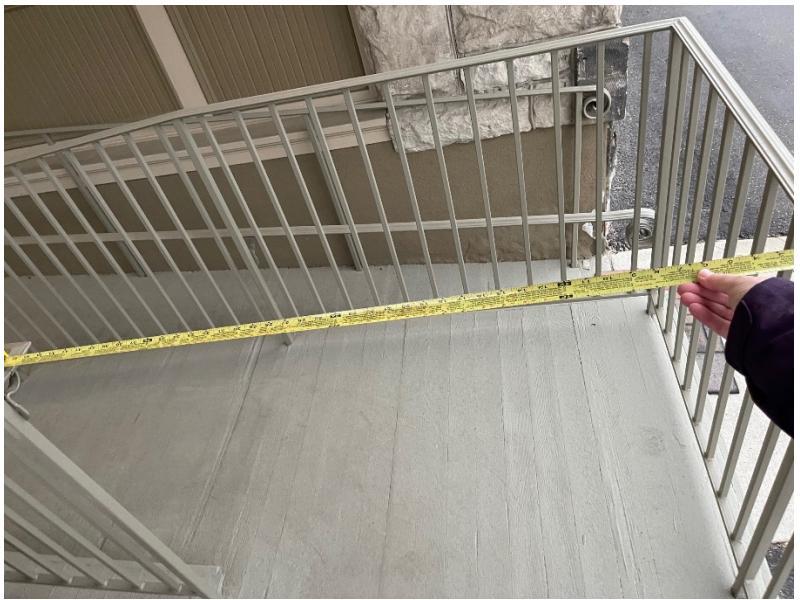
Figure 4 - Photo of ramp landing being measured

Noncompliant Findings: The ramp, which includes changes in direction, does not have landings that are 60 inches by 60 inches in clearance. The photo below (Figure 4) shows a measurement of 47.5 inches, which is less than the required 60 inches.

Additional Recommendations: The location of the ramp entrance from street level can be difficult to identify. Adding appropriate signage directing those who need ramp access would improve awareness of the ramp location and clearly identify the accessible pathway/entrance to the building.

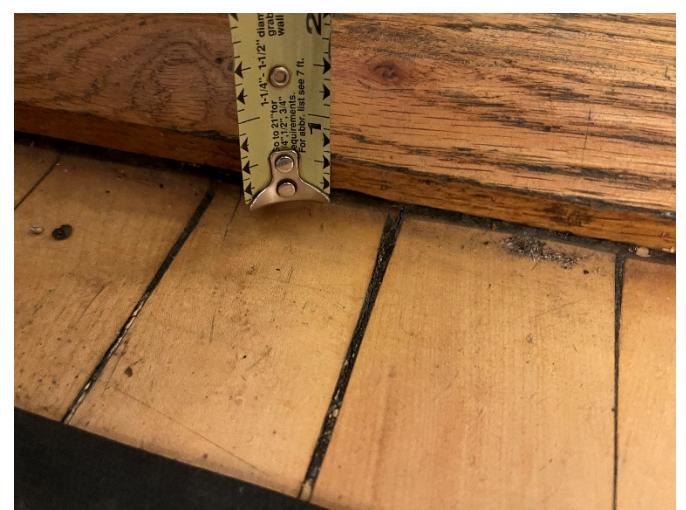
Figure 6 - Photo of threshold vertical edge being measured

5. **Noncompliant Findings:** The threshold of the front door has a vertical edge of 5/8 inches, which is greater than the maximum required edge of ¼ inches.

The photo below (Figure 6) shows the measurement taken of the noncompliant vertical edge and the threshold in relation to the front door (Figure 7).

Recommendation: Replace with a compliant threshold or modify the existing threshold so that it has a maximum ¼ inch vertical edge below the bevel and a total threshold height, including the beveled edge of ½ inch to ¾ inch for existing altered thresholds.

- i. If a client is in a wheelchair, employees will direct the client to Meridian location that is wheelchair accessible.
- 3. Door Threshold
 - a. A rubber threshold was installed onto the existing threshold that meets regulations.

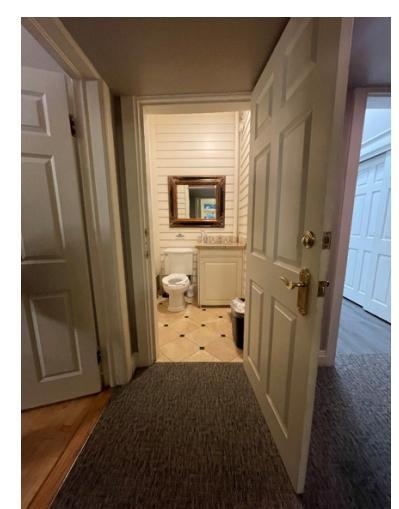
Figure 9 - Single use nonassessable bathroom

Noncompliant Finding: The single use restroom (Figure 9) that is accessible to the public is not compliant with the standards set forth in the ADA.

- 4. Bathroom
 - a. The existing bathroom at the Boise location does not meet current ADA accessibility standards, including clear floor space, fixture heights, and maneuverability requirements. However, because the property is recognized as a historic structure, it is grandfathered under ADA Title III regulations. These regulations allow exceptions when full compliance would threaten or destroy the historic significance of the building. As a result, modifications to the bathroom are not mandated unless they can be made without compromising the building's historic character.
