RE: ADA Technical Review of Faces of Hope Building

In response to your request, please find a formal technical review of the parking lot, the pathway from the parking lot, the access ramps to the customer entrance, and areas in the facility that are accessible to the public for the Faces of Hope office located at 209 West Main Street in Boise.

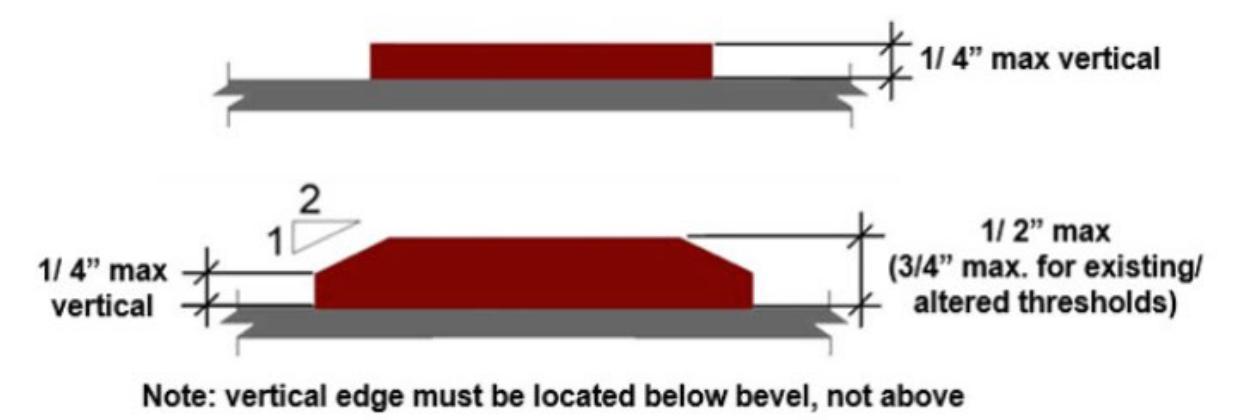
Figure 5 - Illustration of threshold requirements

4. <u>Thresholds</u>: Thresholds of doors need to meet standards to prevent trip type hazards for wheelchair casters and other mobility devices. The height of thresholds is limited to ½ inch in new construction. The edge must be beveled 1:2 maximum above a height of ¼ inch. A maximum height of ¾ inch is permitted for existing or altered thresholds if they have a beveled edge on each side with a slope not steeper than 1:2. These requirements apply to all types of doors required to comply, including sliding doors. The image below (Figure 5) illustrates the threshold requirements.

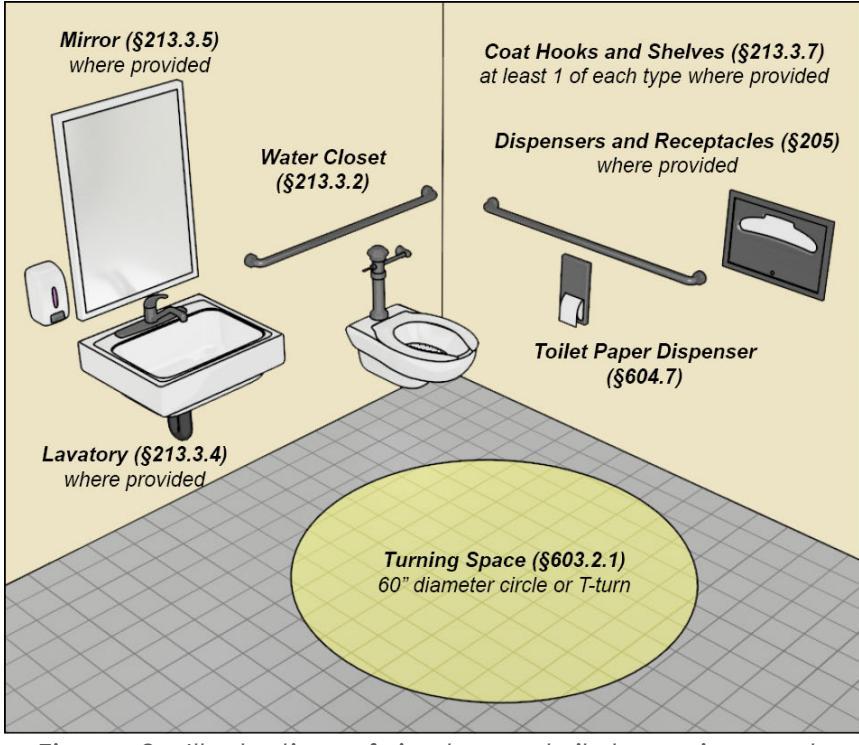
Figure 8 - Illustration of single use toilet requirements

6. <u>Components of Accessible Single User Toilet Room:</u> Accessible restrooms allow a person using a wheelchair to enter the bathroom and close the door, safely transfer onto the toilet, access the toilet paper dispenser, and use the sink, the paper towel dispenser, and hand soap. Requirements in the Standards for toilet rooms address doors, turning space, plumbing fixtures, mirrors, dispensers, shelves, and other elements provided. Other provisions in the Standards also apply. Figure 8 below illustrates the different requirements for a single user toilet room.
